**Warning Letter and Return to Compliance**

**Purpose:** RCRA Compliance Evaluation Inspection

**Facility:** Associated Plating Co.

**Date of Investigation:** October 26, 2010

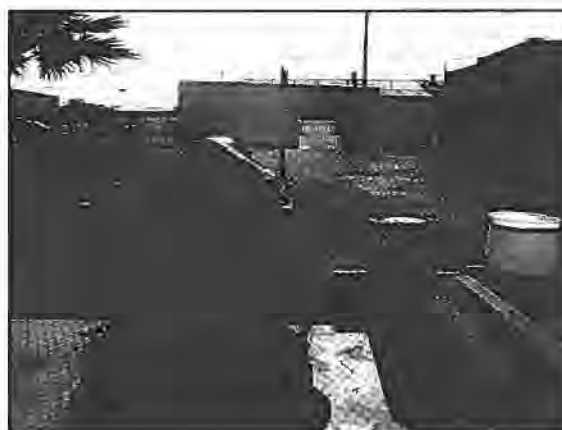
The inspectors evaluated the 90-day storage area which is located in an enclosed yard South-East of the building (see photograph to the right). At the time of the inspection only 3 containers of hazardous waste were being stored in the area: 1.) supersack of metal hydroxide sludge (F006) dated 8/25/10; 2.) 55-gallon drum of metal filters contaminated with cyanide (F008) dated 9/7/10; and 3.) supersack of non-RCRA hazardous waste nickel filters (CA 181) dated 9/2/10. All containers were closed and properly labeled with the required information.

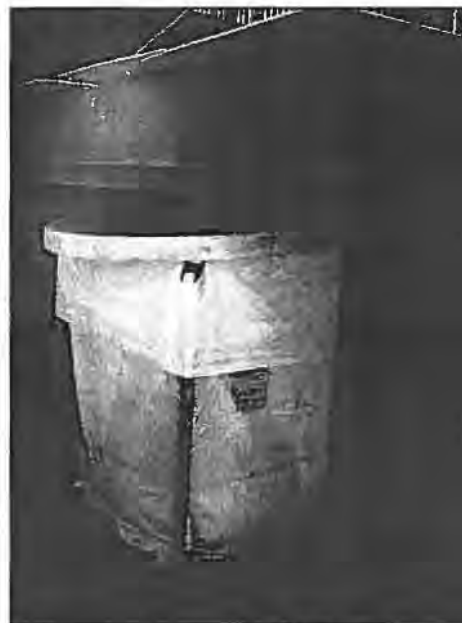
below on the right) where sludge is transferred from the bin into a supersack container. The bin of F006 filter cake on the unit was covered as required and the supersack which was actively being filled with sludge was properly labeled and the accumulation start date of October 1, 2010 was clearly noted. No potential hazardous waste violations were observed in the wastewater treatment area.

Sludge Transfer Unit
